A Case Study for the EDGE On-line Tool

[SHADOW WOOD PRESERVE]

Green Roof Evaluation

March 2009

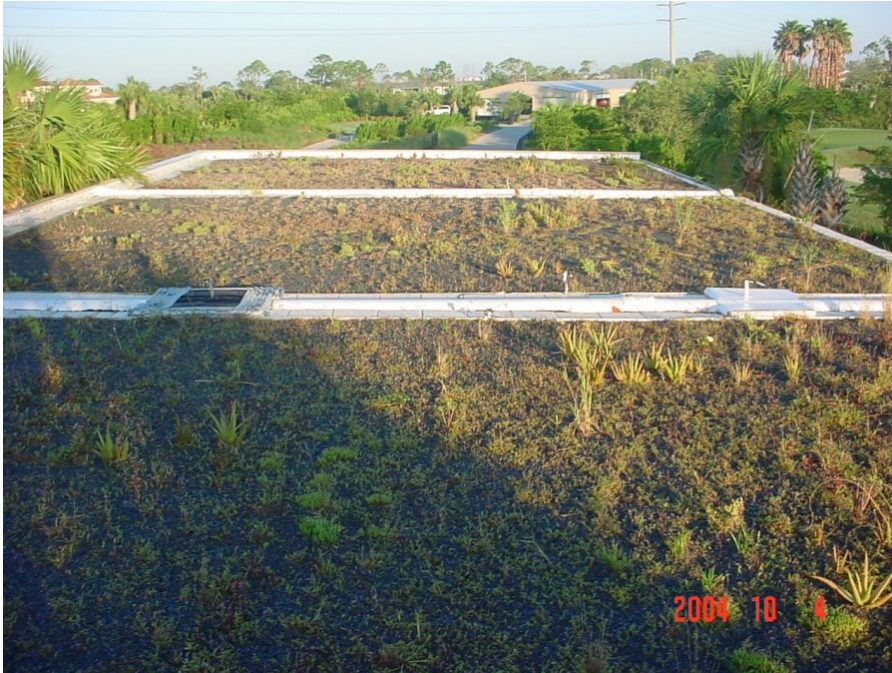
Figure 2-Roof Plantings Oct 2004

The three roof plots were planted during the week of July 12, 2003. A total of 1433 plants were installed, generally with plants of each variety distributed in groups of 1- to 15 across each of the three roof areas. It quickly became apparent that the *Sedum* varieties could not withstand the humid, high moisture summer conditions, and most of the *Delosperma* varieties were not durable. The other plants in the trial, however, thrived, including *Aloe*, *Euphorbia*, and *Portulaca*. Present near the end of the initial phase but less robust were *Tibouchina* and *Agapanthus*.

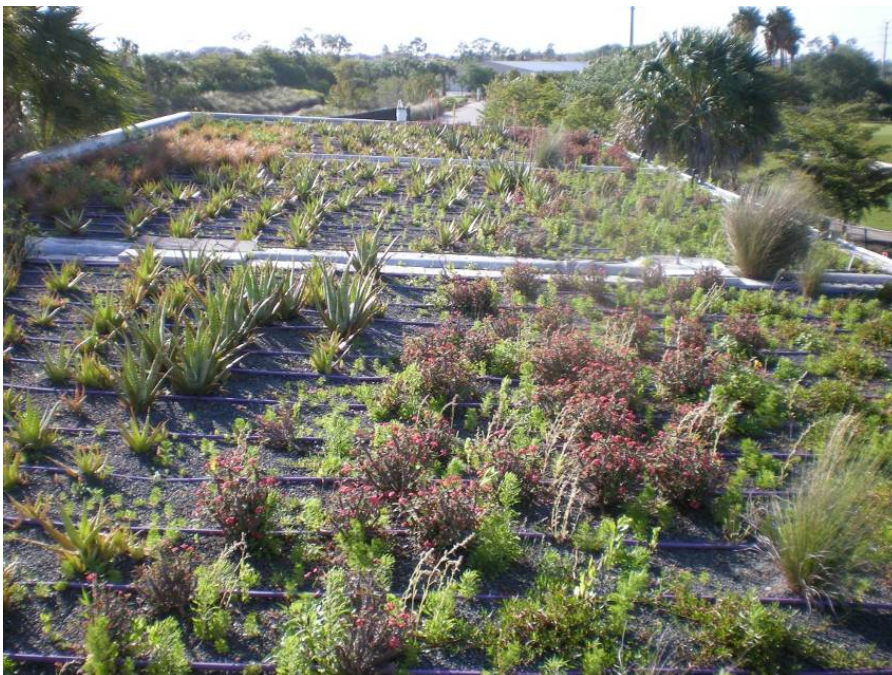
Figure 3-Roof Plantings March 2008

The project has undergone a replanting following the installation of a cistern in early 2006 that collects roof runoff to provide water for a new low volume drip irrigation system. The new plants bedded well and the roof returned to full operational status in the summer of 2006 with resumption of the water quality sampling and roof thermal characteristic monitoring. Since then, the plant viability and stability increased significantly, primarily due to irrigation and a plant selection better matched to hot wet summers and dry winters. New plantings included Beach Purslane, Beach Sunflower, Aloe, Crown of Thorns, Mulhy Grass and Cordgrass.

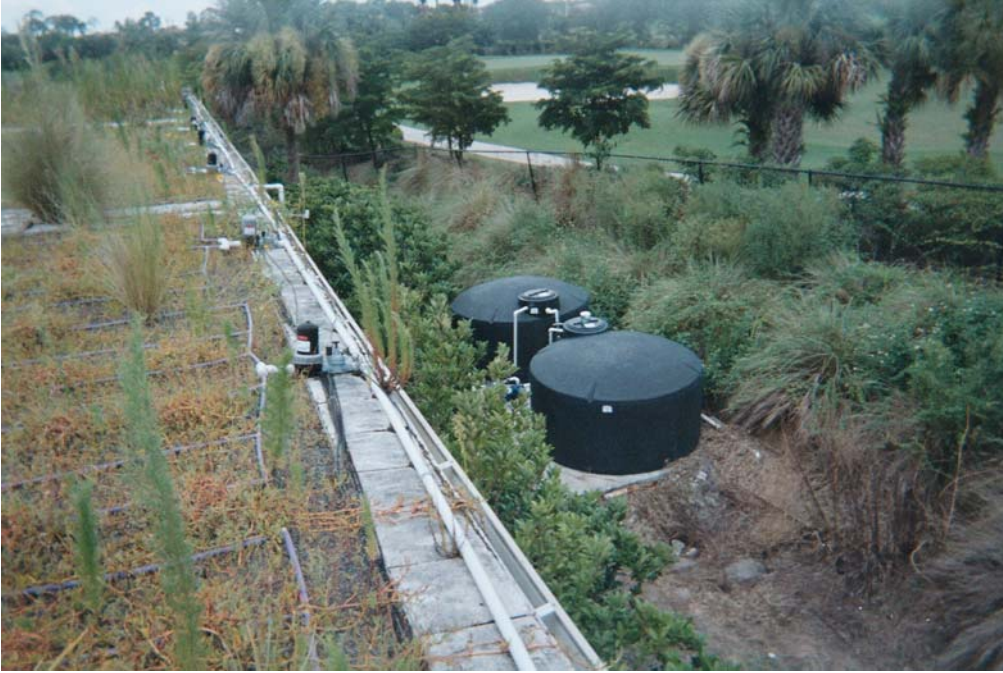
Figure 4-Irrigation Cistern System

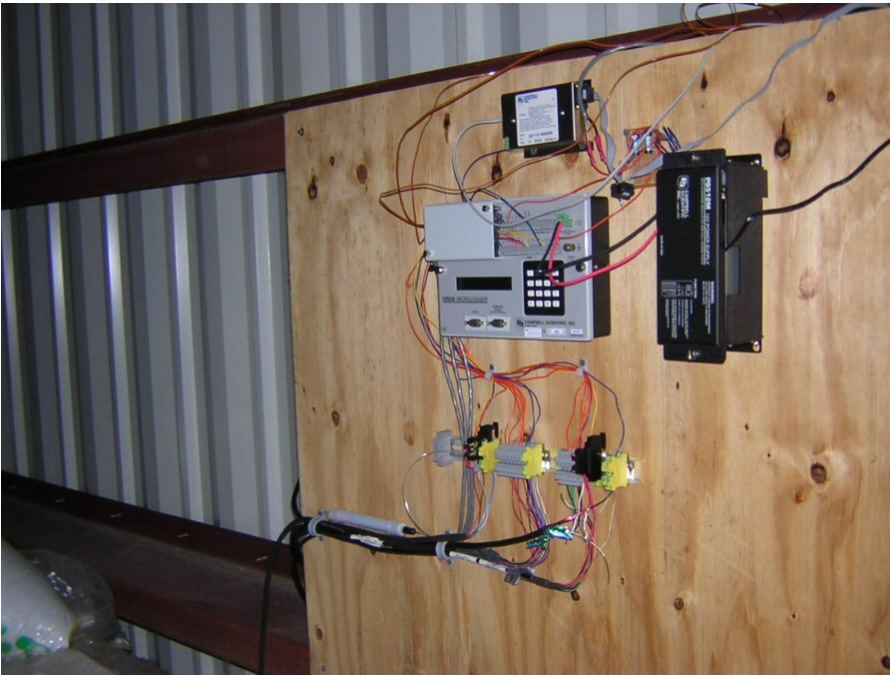
Figure 5-Roof Sensor Wiring and Datalogger

Roof thermal characteristics are recorded from readings produced by a set of sensors installed on and in the roof media and stored in a standard Campbell Scientific datalogger for later analysis.

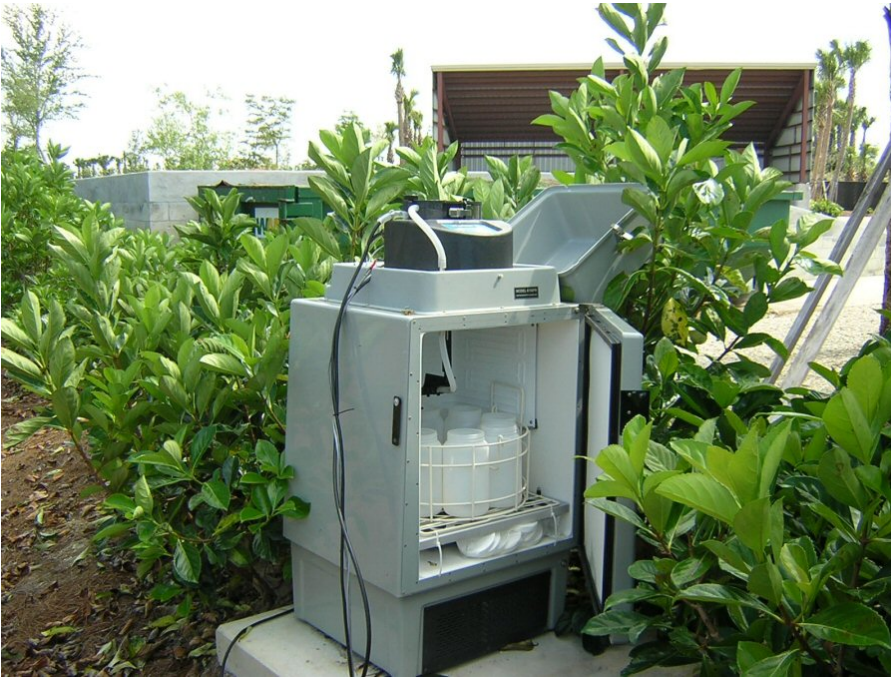
Figure 6-ISCO Automatic Refrigerated Sampler

maintained by Johnson Engineering. Sampling equipment is composed of ISCO automated, programmable refrigerated samplers capable of operating in a flow compositing mode. The samplers are triggered by standard tipping bucket rain gages, flow measurements determined by an arrangement of rain barrel equipped with a pressure transducer and a series of calibrated orifices.
